# Manhole Inspection Summary

Manhole # S67M\_\_001MH

**Location** Address: **6418 O' Donnel St.**

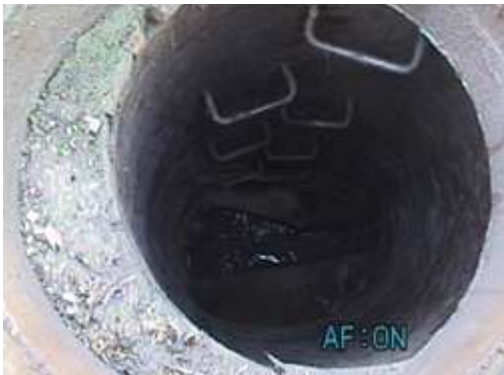
Defect 1

Comments **OFFSET 3INCHES. 6 O'CLOCK IS CAPPED OFF.**

**Frame** Offset: **3** (in.) Condition: ☐ Sound ☐ Cracked ☒ **Leaks**

Offset frame

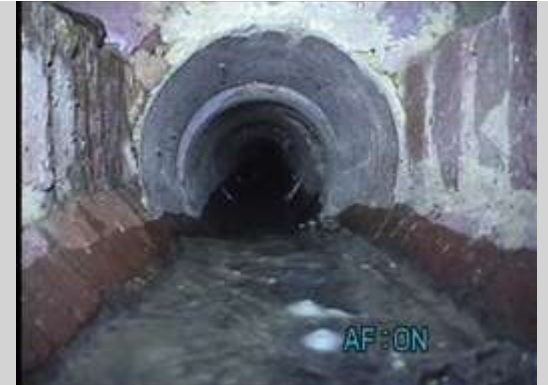
12 O'Clock Outflow

8 in. Circular Gravity Sewer  
Pipe Out @ 12 O'Clock

Pipe Height: **8.4** (in.) Rod and Bar (Angled)  
Pipe Material: **Clay** ☐ Pipe Lined  
Invert Depth: **10.83** (ft.) Flow Characteristics: **Slow**  
Deposits: ☐ None ☐ Mud ☒ **Sludge** ☒ **Debris** ☐ Grease  
Silt Depth: **1** (in.) Deposits Extent: **Medium**  
Infiltration: **None** Pipe Seal Cond: **Sound**

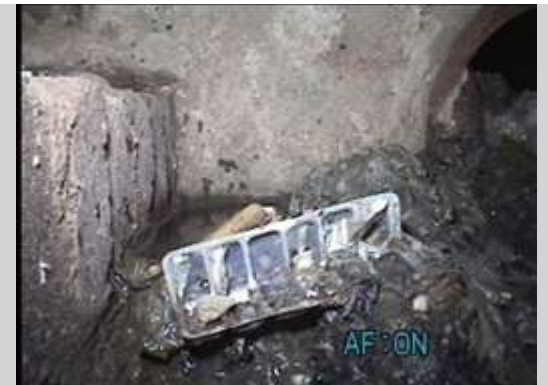
6 O'Clock Inflow

Pipe In @ 6 O'Clock

Pipe Height: (in.) Rod and Bar  
Pipe Material: ☐ Pipe Lined  
Invert Depth: (ft.) Flow Characteristics: **None**  
Deposits: ☐ None ☐ Mud ☒ **Sludge** ☒ **Debris** ☐ Grease  
Silt Depth: **3** (in.) Deposits Extent: **Heavy**  
Infiltration: **None** Pipe Seal Cond: **Unknown**

Connects To: **Stub connection / abandoned**

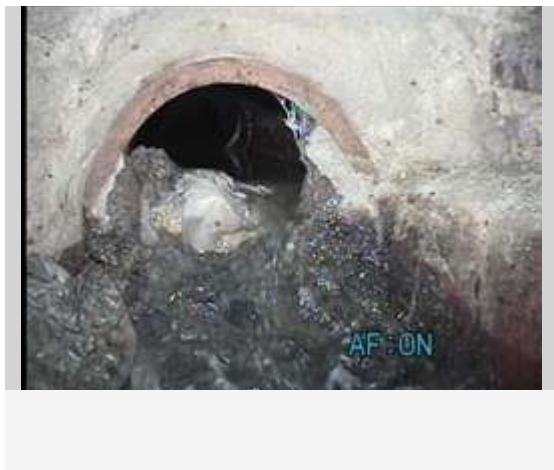
7 O'Clock Inflow

10 in. Circular Gravity Sewer  
Pipe In @ 7 O'Clock

Deposits: ☐ None ☐ Mud ☒ ~~Sludge~~ ☒ **Debris** ☐ Grease

Silt Depth: **2** (in.) Deposits Extent: **Heavy**
